Emergency response to the Beirut Blast

-End of mission report-

Blue Shield Mission August 2020 – November 2020

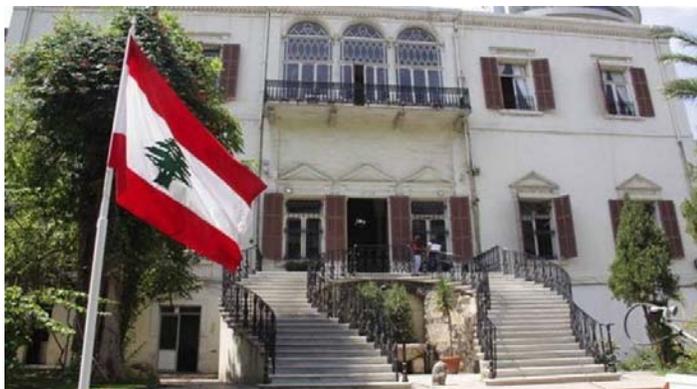
MoFA Building – plot 31 Rmeil
BEFORE BLAST

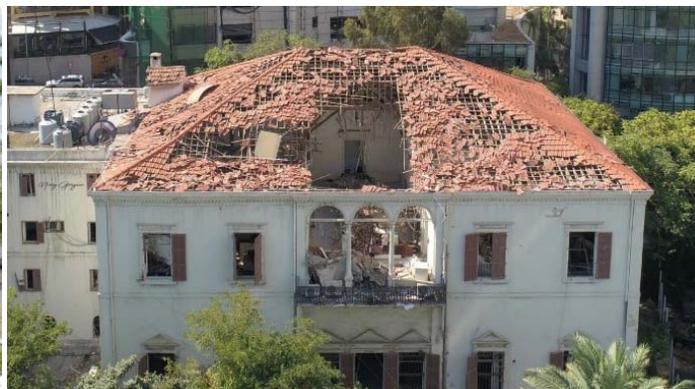
MoFA Building – plot 31 Rmeil
AFTER BLAST

The MoFA building – Plot 31 Rmeil, a XIXth century palace built by the illustrious mercantile Bustrous family that marked Beirut's history, that was chosen by the nascent Lebanese state as the hub of its international dealings, and where the ministry of foreign affairs was implemented. Unfortunately, the blast took a toll on the 150yr old building and resulted in the complete loss of all doors and windows, the damaging of the roof structure and the loss of tiles, and subsequently the detachment of the northern wall. The inside of the building, namely its two floors, was filled with a large amount of rubble and debris that included various architectural and decoration elements and antique furniture; its Baghdadi ceiling (traditional construction of the inside ceilings consisting of wood, grills and plaster layers, held by the roof structure) was severely damaged and partly collapsed and obstructed entry to areas of the building.

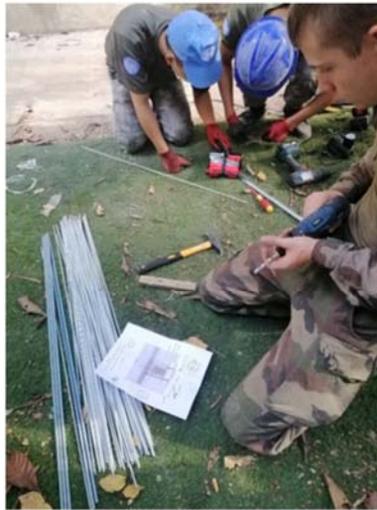
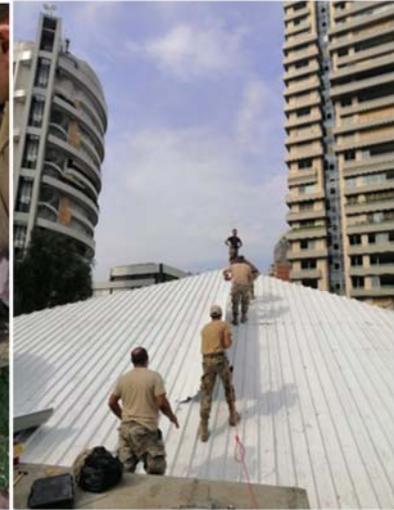
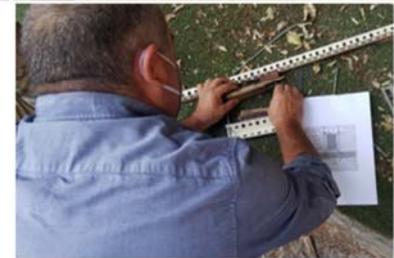
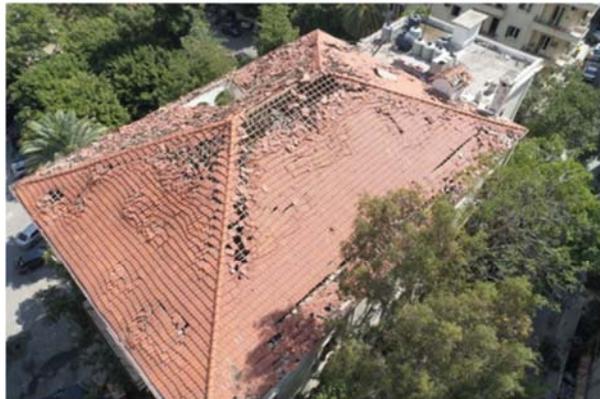
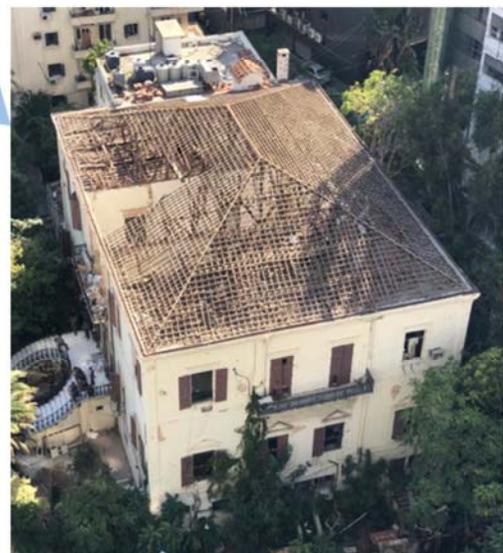
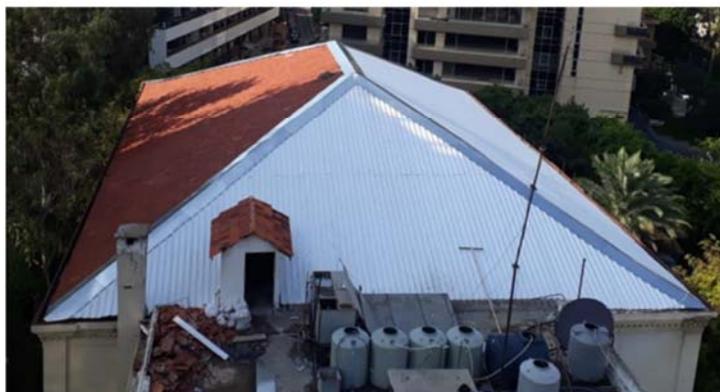
Blue Shield provided the expert in roofs and architect Jean Samaha who coordinated with the LAF Works & Engineering Regiment to elaborate the detail for securing the roof structure and fixing the ToT. On the other hand, UNIFIL prepared the material on the ground and delivered it to the roof for the LAF for attachment

Roof cleared from all rubble and broken tiles

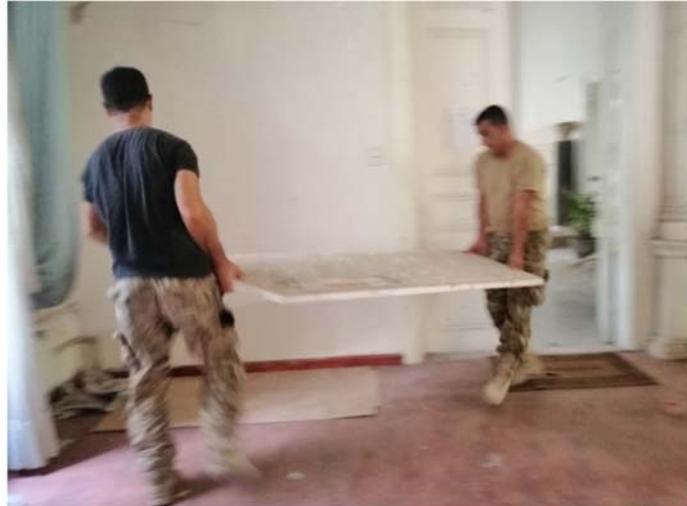
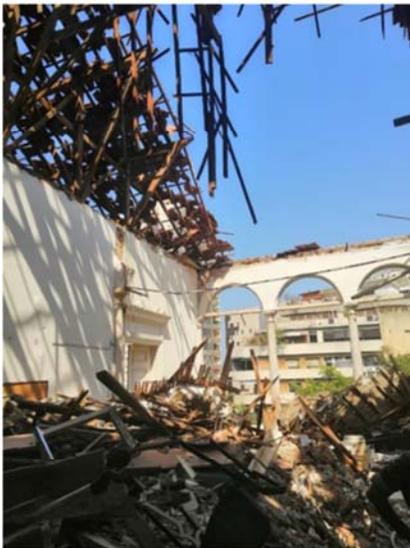
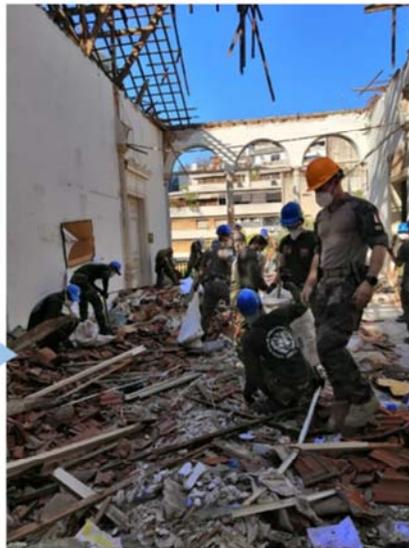
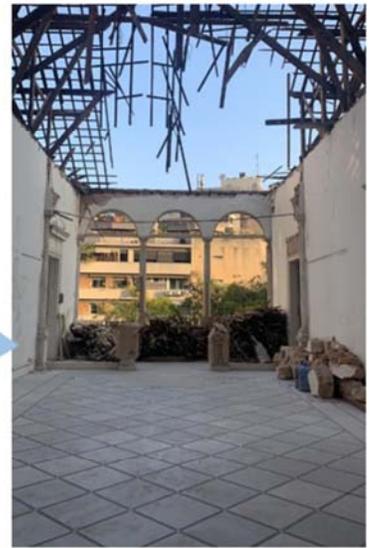
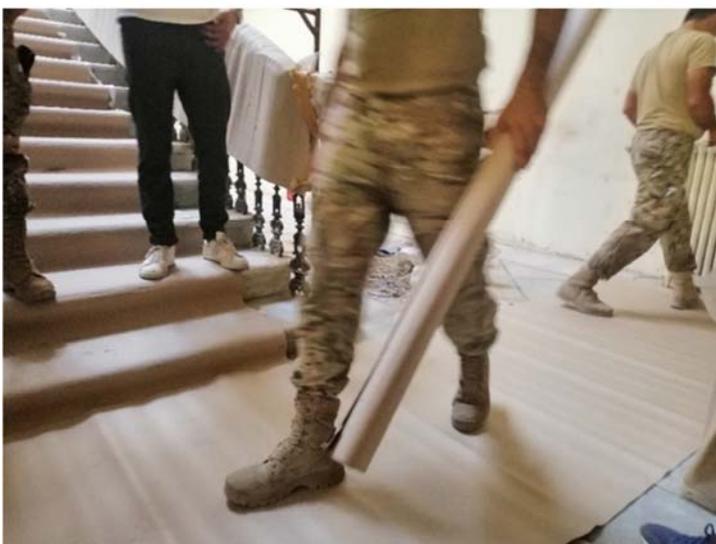
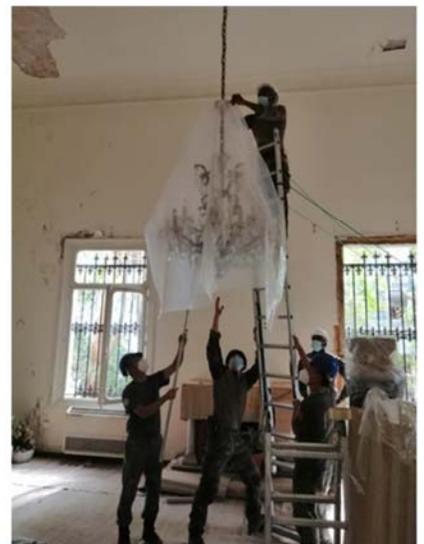
LAF removed official documents left in the building, and moved antique furniture to designated location. Blue Shield & DGA provided professional assistance to the UNIFIL for the sorting of antique furniture and architectural elements. LAF worked on protecting architectural elements in-situ by covering them [floors-pillars...] UNIFIL covered antique chandeliers

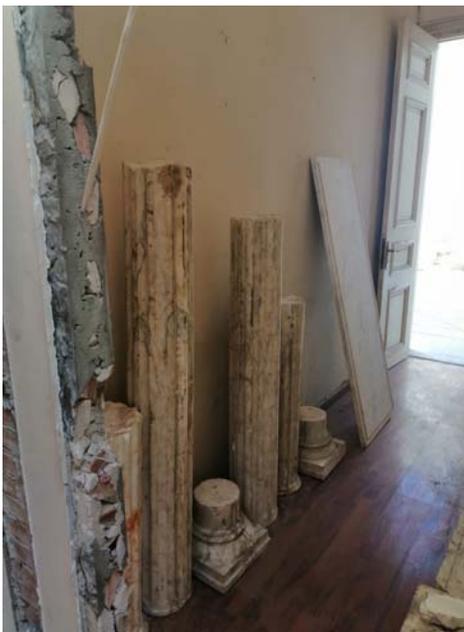
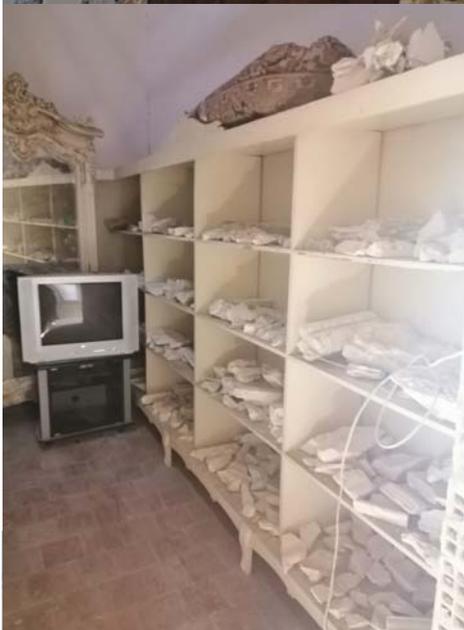
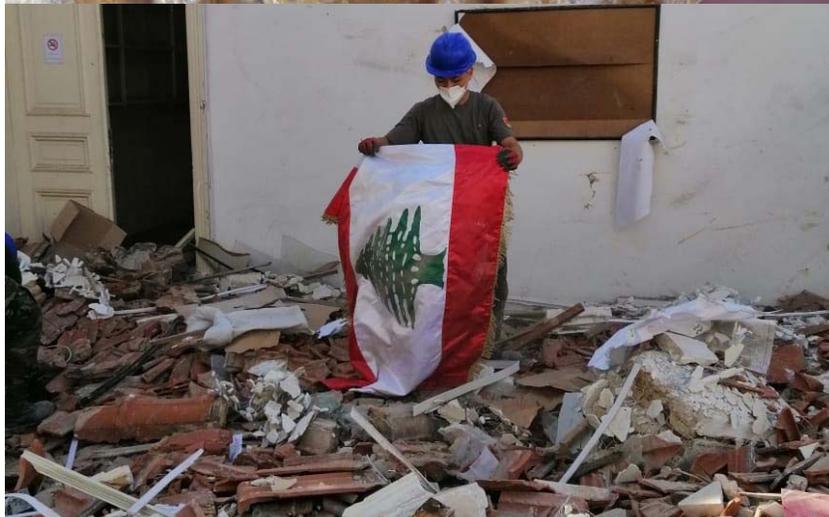
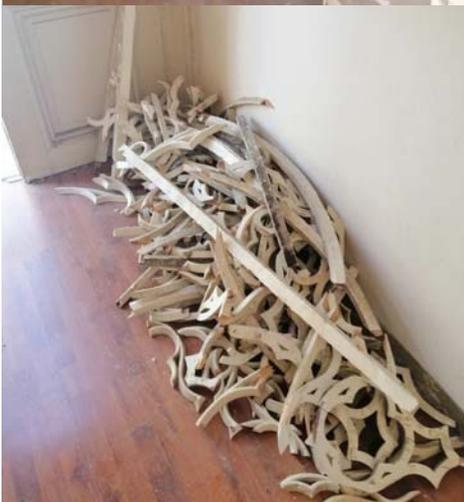
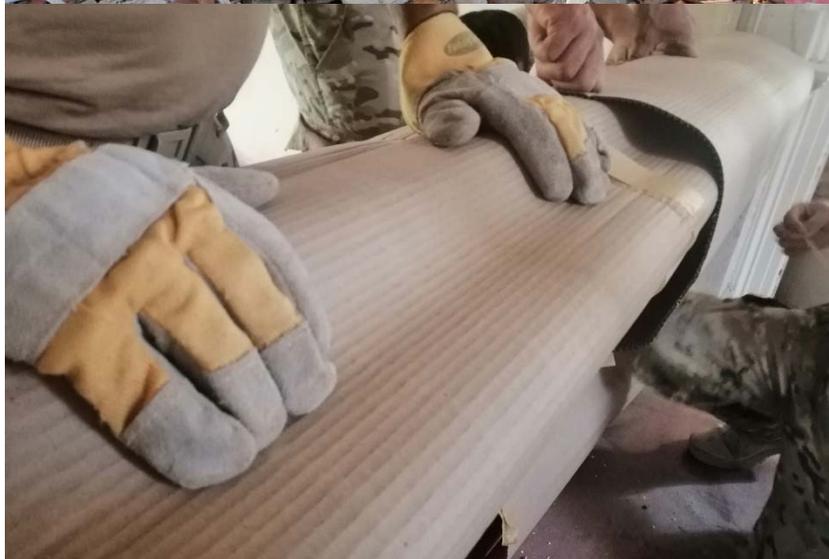
Storage of architectural elements and decoration needed for the reconstruction

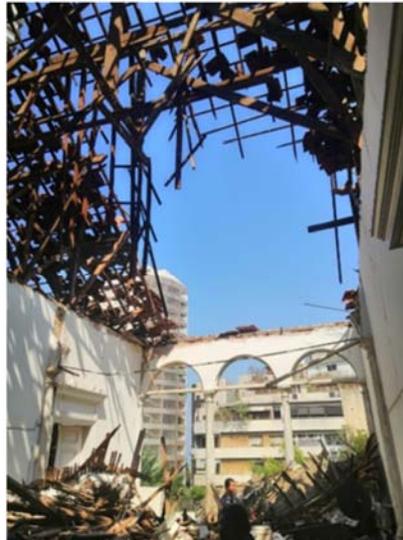
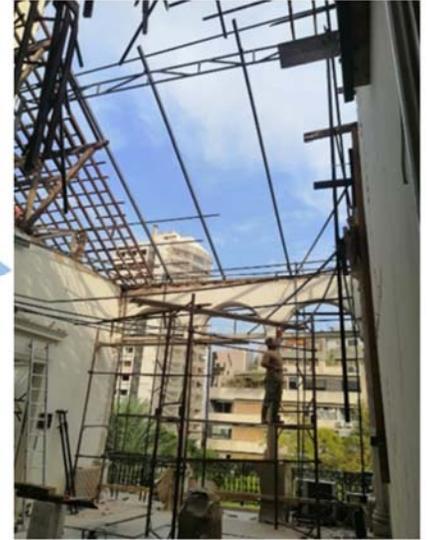
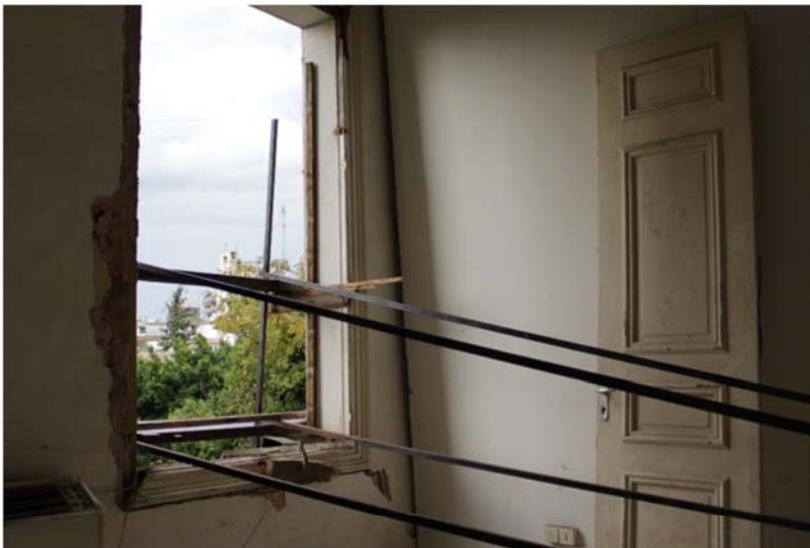
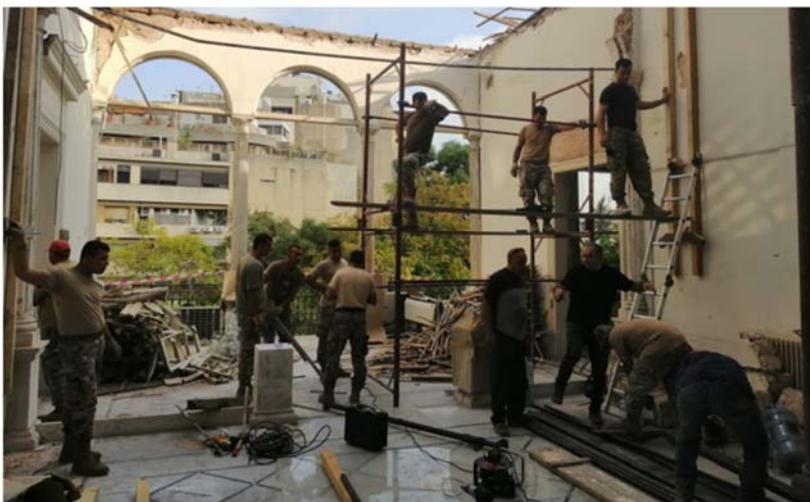
Blue Shield provided the expert in roofs and architect Jean Samaha who coordinated with the LAF Works & Engineering Regiment to elaborate temporary propping that would not obstruct future reconstruction efforts. UNIFIL prepared the material on the ground and delivered it to the LAF to use to maintain the North wall and the main arcade by fixing it to more stable walls.

Roof structure and 3 arches held by the propping and bolted into secure walls

Propping running from wall to wall and fixing the detached wall to more stable areas of the structure and splitting the weight in between all the walls

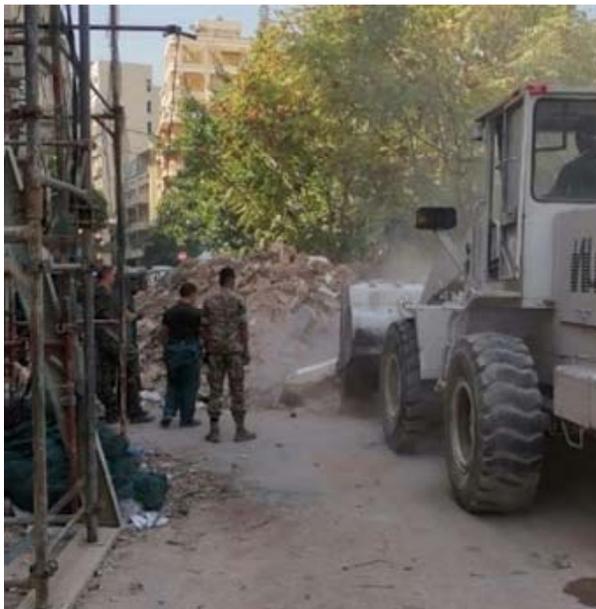
Selim Bustros Street was blocked by rubble from another devastated historical building on the plot 726 Rmeil. It blocked a side road essentially used by the residents to bypass main roads in their day to day lives. In this instance, same as the one before, UNIFIL and BS provided the heavy machinery while both armies did the sorting of the rubble. Conversely, in this case, the architectural elements were stored in the building owner's backyard for imminent restoration. The LAF also provided convoys and specific areas for the unwanted rubble to be stored and the DGA provided storage for the sandstone blocks.

Selim Bustros Street
BEFORE RUBBLE CLEARING

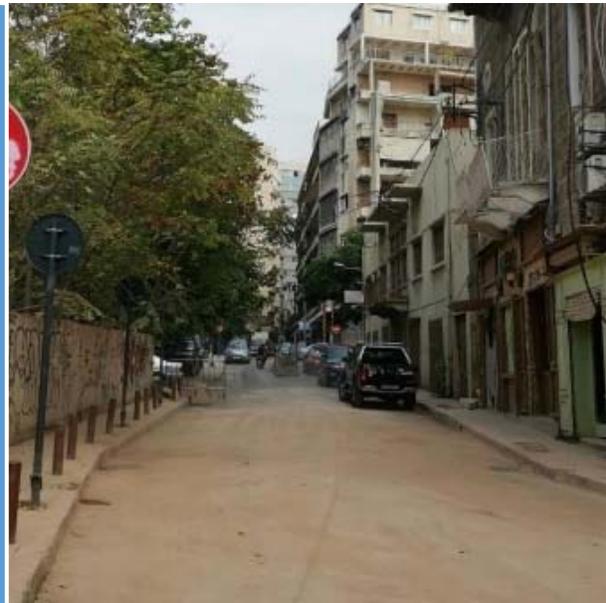
Gouraud Street, was blocked by rubble from a destroyed building existing on plot 733. The street is one of the main arteries of Achrafieh connecting it to the highway on one side and connecting the central districts to the North. It caused traffic in the area and slowed down the efforts to fix the neighboring areas.

Due to the fact that the collapsed building is of historical significance, the DGA and Blue Shield sent their experts to be present on the field while the LAF and UNIFIL troops carefully sorted the rubble and stacked all important material (sandstones, cement molds, and other architectural elements) on the side to be sent to the DGA stores for safekeeping.

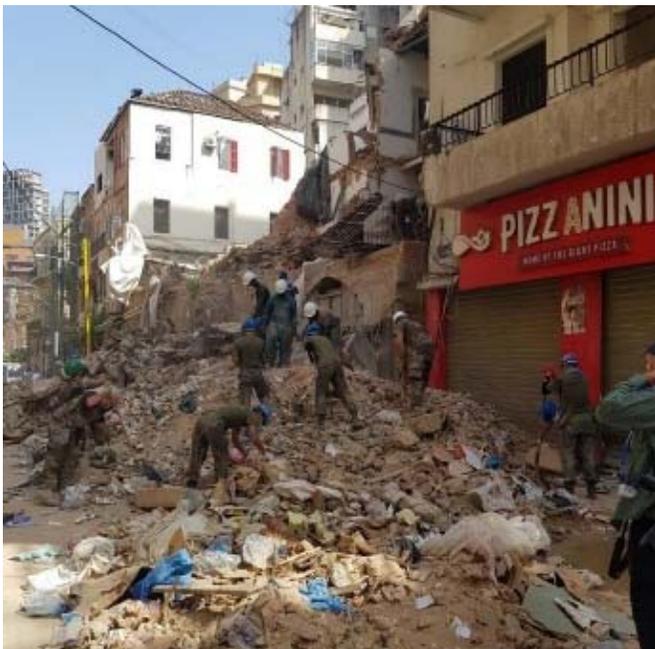
Gouraud Street
BEFORE RUBBLE CLEARING

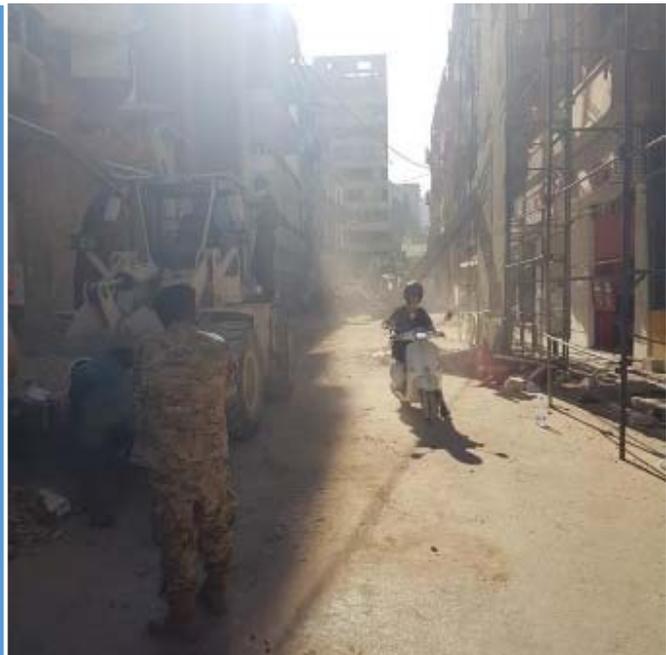
Gouraud Street
AFTER RUBBLE CLEARING

UNIFIL and BS provided the heavy machinery such as tractors and trucks for the lifting and the effectiveness of both forces were arranging the material from the debris in clear piles for the DGA to catalogue, while the LAF provided special convoys for the unwanted rubble trucks to specified landfills in the port area.

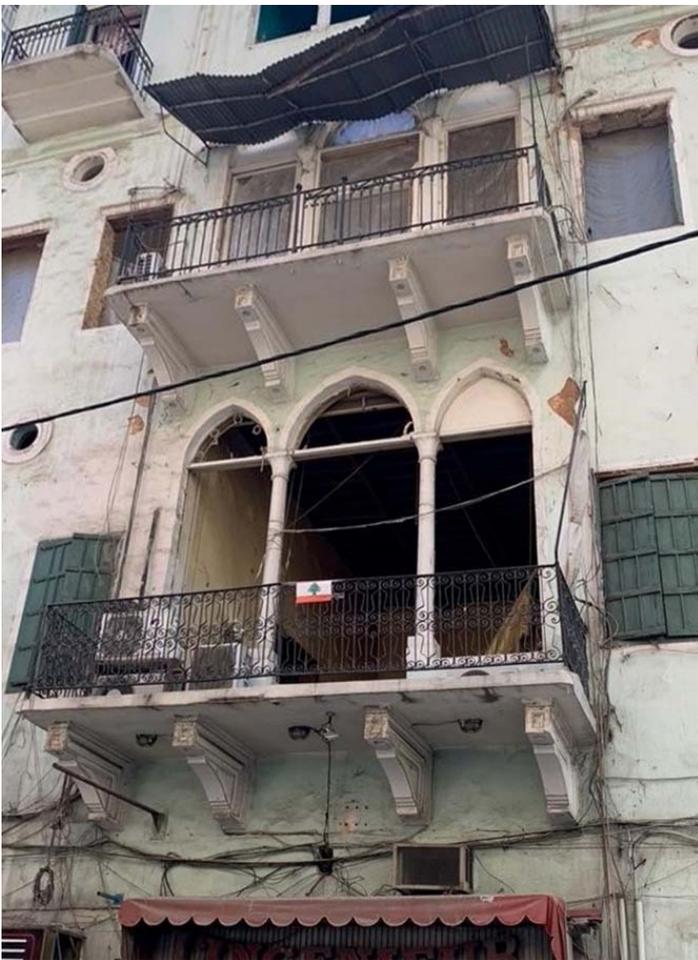
Ghoulam house A – plot 1137 Rmeil
AFTER BLAST

All openings were left gaping after the blast and the building was exposed to the elements which would provoke more damage. Blue Shield assigned a number of the UNIFIL troops to help with the clearing of the furniture of one of the floors into a private truck rented by the owner to be able to go in and close the windows and doors. The material for the closing (flex rolls of 0.7mm in wooden frames of 4x4cm) as well as the tools were provided by Blue shield.

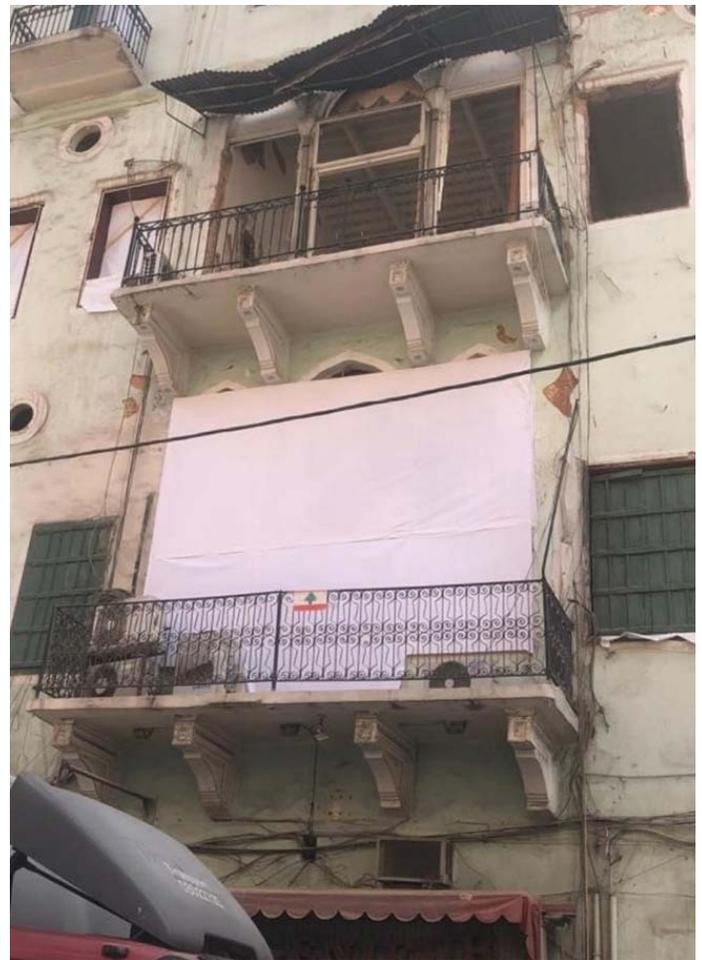
Ghoulam house A – plot 1137 Rmeil
AFTER INTERVENTION

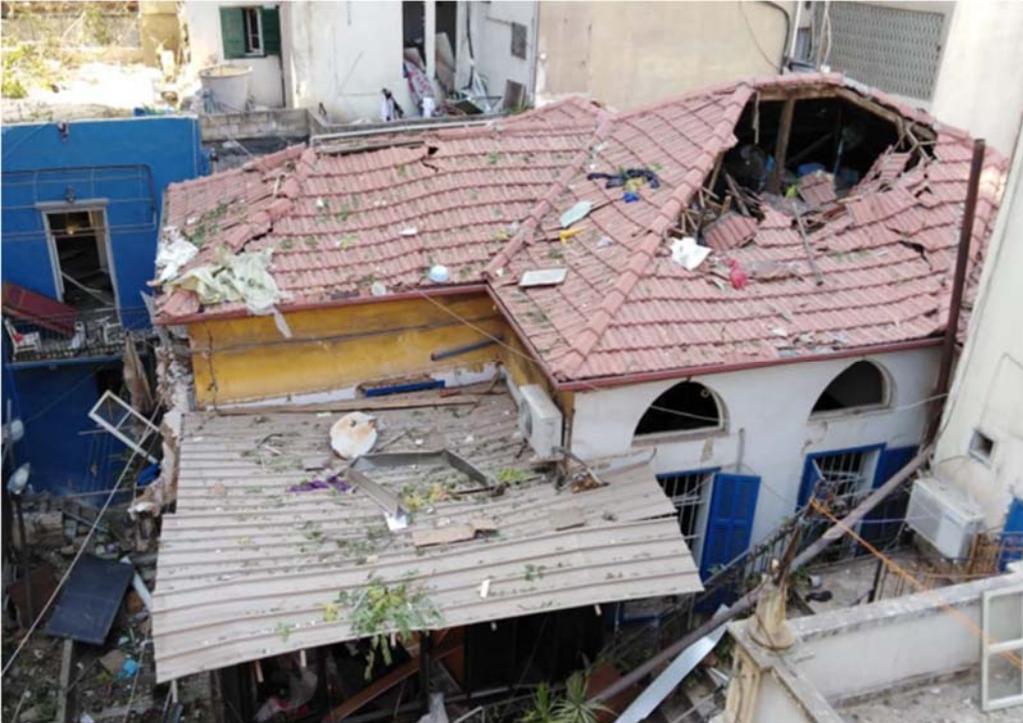
All windows and doors were blasted and had to be urgently secured, and more importantly the tiled roof had a hole in the middle which left it exposed to the elements threatening its structural integrity. The wall previously cited is the North façade in this building. The DGA sent in engineers to place temporary propping to hold it and the roof. The UNIFIL and LAF troops started with emptying the house and moving the furniture to the truck rented by BS in order to be able to work in this house. Once this task done, both troops moved in to intervene first to remove unwanted debris and second, on covering the roof with the same material (flex rolls of 0.7mm in wooden frames of 4x4cm). Once the roof covered, the UNIFIL proceeded with closing down the windows and doors.

Ghoulam house B
plot 474 Rmeil
AFTER BLAST

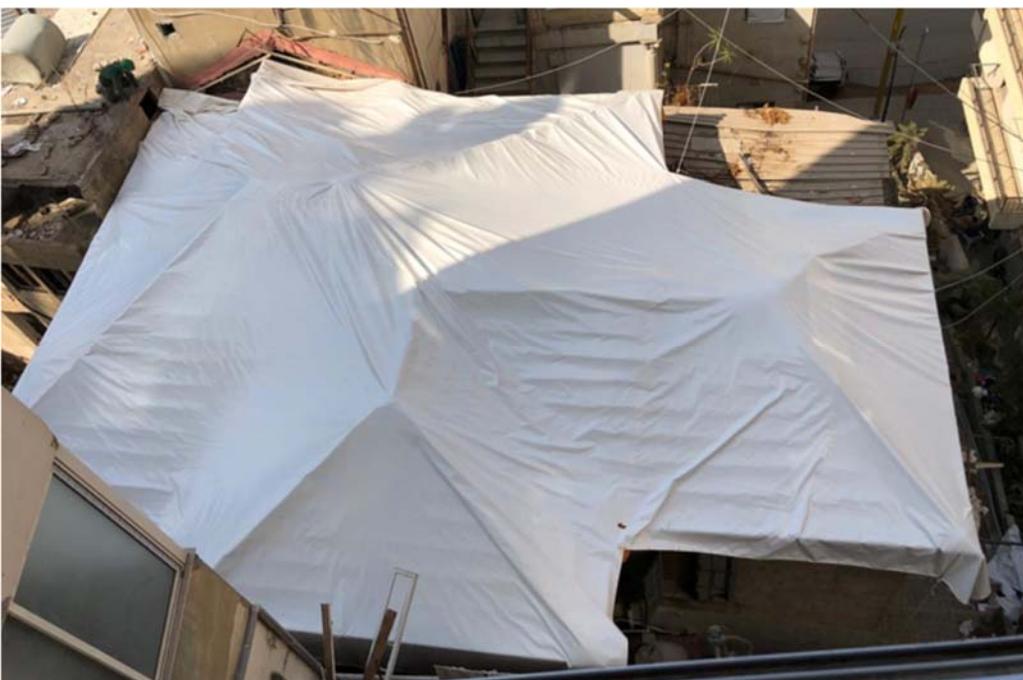
Ghoulam house B
plot 474 Rmeil
AFTER INTERVENTION
